Manhole Inspection Summary

Manhole # S25EE2014MH

Insp Date: **11/6/06 3:13 PM**

Location Address: **915 DROHOMER PL**

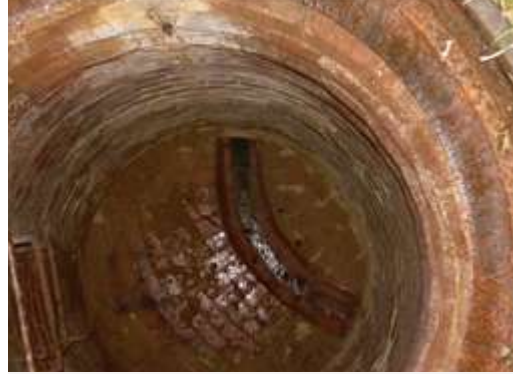
Top View

Corroded steps. Bench debris.

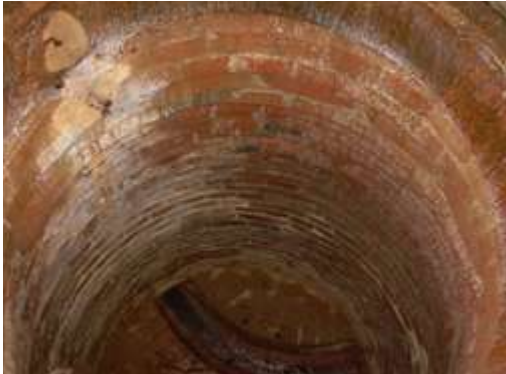
Defect

Frame leaks. Adjustment and Barrel infiltration.

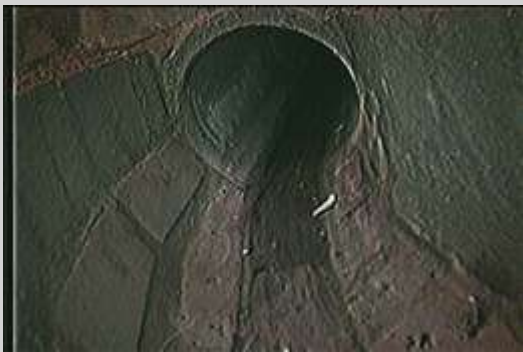
8 in. Circular Gravity Sewer Pipe Out @ 12 O'Clock

Infiltration: **Evidence** Pipe Seal Cond: **Unknown**

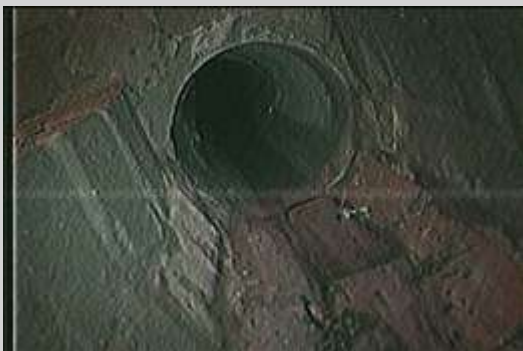
8 in. Circular Gravity Sewer Pipe In @ 4 O'Clock

Infiltration: **Evidence** Pipe Seal Cond: **Unknown**
